Alpine Road Slip-out Repair Project Description **County of San Mateo Department of Public Works**

The County of San Mateo Department of Public Works (County) is proposing to reconstruct three roadside slip-outs (Sites 1 and 2) along Alpine Road north of the Joaquin Road intersection, within the community of Los Trancos in unincorporated San Mateo County (see attached maps). Alpine Road is one of two key access routes into and out of the Los Trancos community. The slip-outs occurred on the steep slopes directly above Corte Madera Creek, which parallels Alpine Road at the project locations. Corte Madera Creek flows into Searsville Lake, a manmade reservoir, which then flows into San Francisquito Creek and San Francisco Bay.

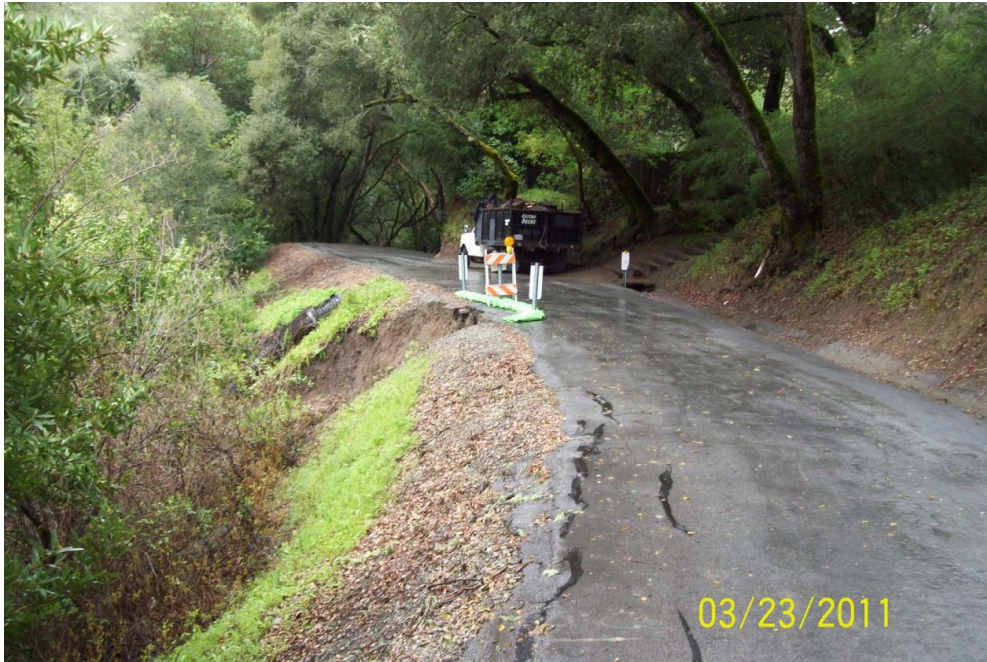
The Site 1 slip-out is located along Alpine Road approximately 0.1 miles north of the Joaquin Road intersection. The slip-out was first discovered in March 2011 following a storm event. Additional slope failure occurred following a series of large storms in December 2012. The failure resulted in the loss of an embankment adjacent to the road and subsequent diminished stability of the road (Photo 1). Currently, the slip-out extends from the edge of pavement to Corte Madera Creek, below (Photo 2).

The dimensions of the slope failure that occurred are estimated to be approximately 35 feet in length (parallel to the roadway) and approximately 25-feet from the roadway surface to Corte Madera Creek, below. The County proposes to reconstruct the upper embankment section of the slip-out.

Photo 1 – Site 1: Photo taken on March 23, 2011, shortly after the slip-out was first detected. The slip-out resulted in a near vertical drop from the edge of pavement down to approximately 25-feet below the roadway surface.

The failure is to be reconstructed by cutting a 35-foot long by 8-foot wide keyway approximately 12-feet below the roadway, backfilling the constructed keyway with large boulders (3- to 4-foot diameter), and placing 2- to 3-foot diameter rock above the keyway to provide support for a reconstructed road embankment. The revetment would be covered with native or imported soil, seeded with a native plant mix, mulched with sterile rice straw, and covered with erosion control blanket. Live willow stakes and/or branches trimmed from nearby trees will be incorporated into the structure to help stabilize the slope and accelerate vegetation regrowth.

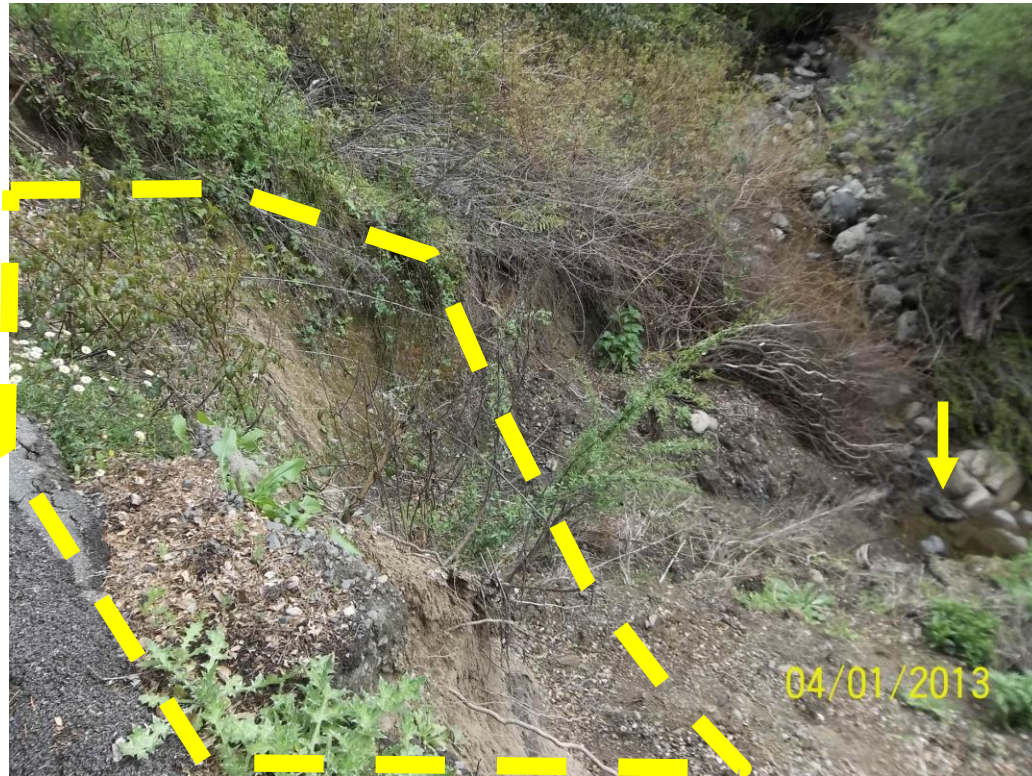
Photo 2 – Site 1: Photo taken on April 1, 2013, following additional bank failure due to large storm events in December 2012. The slip-out currently extends from the roadway to Corte Madera Creek. The County proposes to remediate the upper portion of the embankment (area indicated by dashed line). Location of Corte Madera Creek below the slip-out is indicated by arrow. The creek was dry during a site visit on July 26, 2013.

To perform the work, heavy equipment would be operated from the roadway and silt fencing would be installed beneath the work area to prevent water quality impacts to Corte Madera Creek. Prior to silt fence removal, accumulated soil and debris will be removed and properly disposed of off-site.

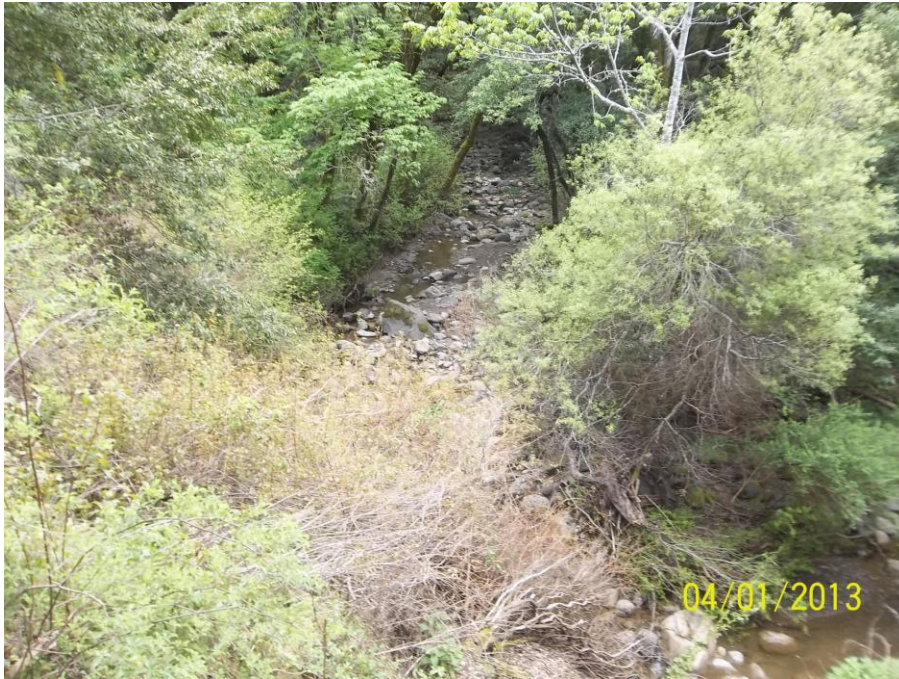
Photo 3 – Site 1: Photo showing Corte Madera Creek and riparian woodland habitat immediately upstream of the Site 1 slip-out.

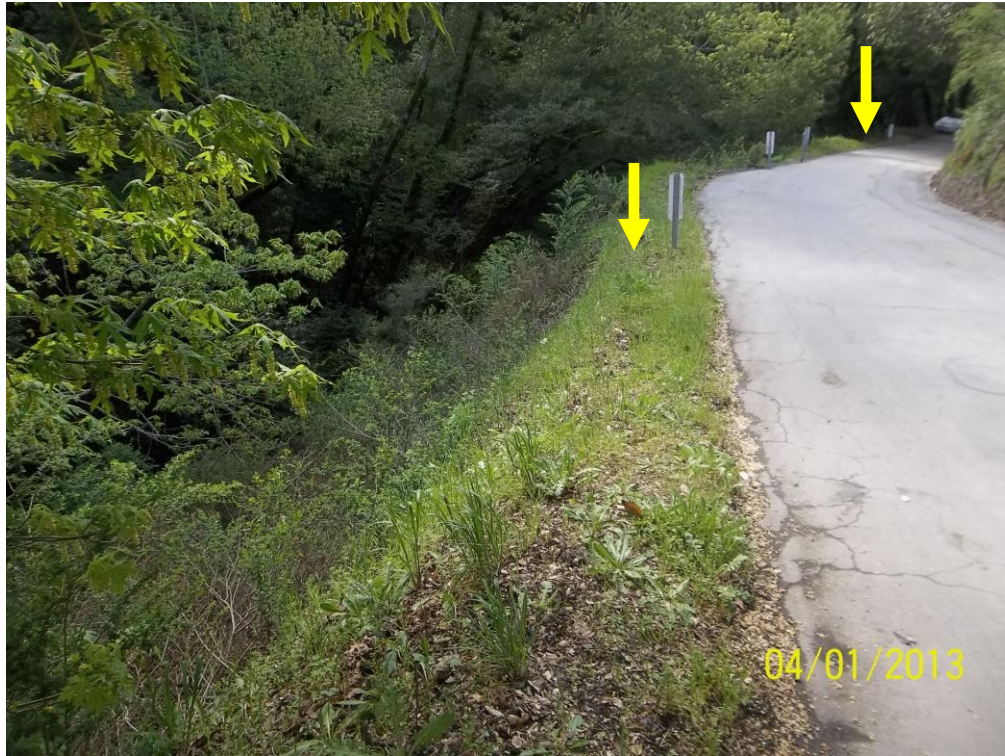
The Site 2 slip-out consists of two adjacent areas of failed roadside embankment, located along Alpine Road approximately 250- to 350-feet north of the Joaquin Road intersection. In 2009, portions of the embankments below the road at this location failed, resulting in the loss of much of the embankment which supported portions of the roadway.

In subsequent years, additional embankment has been lost, to the point where narrow sections of road now have no discernible shoulder and the roadway, no more than 14 feet wide in places, has vertical slopes above and below the road ranging from 20 to 40 feet in height. In order to assure continued passage along this road, it is essential that these failed slope areas be stabilized.

The repair work would be limited to the upper sections of the embankments. Closest to Joaquin Road, the repair would be approximately 80 feet in length (distance parallel to the road) and 15 feet maximum in width (on slope distance between the road and the creek) (Photo 4).

Photo 4 – Site 2: Photo looking north at the adjacent Site 2 slip-outs, located along Alpine Road approximately 250- to 350-feet from the Joaquin Road intersection.

The County is proposing the installation of soil nails and a shotcrete facing to support portions of the slope immediately beneath the road. Soil nails would either be launched into the hillside at equally spaced intervals or drilled into the hillside, set in place, and then sprayed with concrete. Once the nailing has been completed, the upper embankment would be reconstructed to recreate a roadway shoulder.

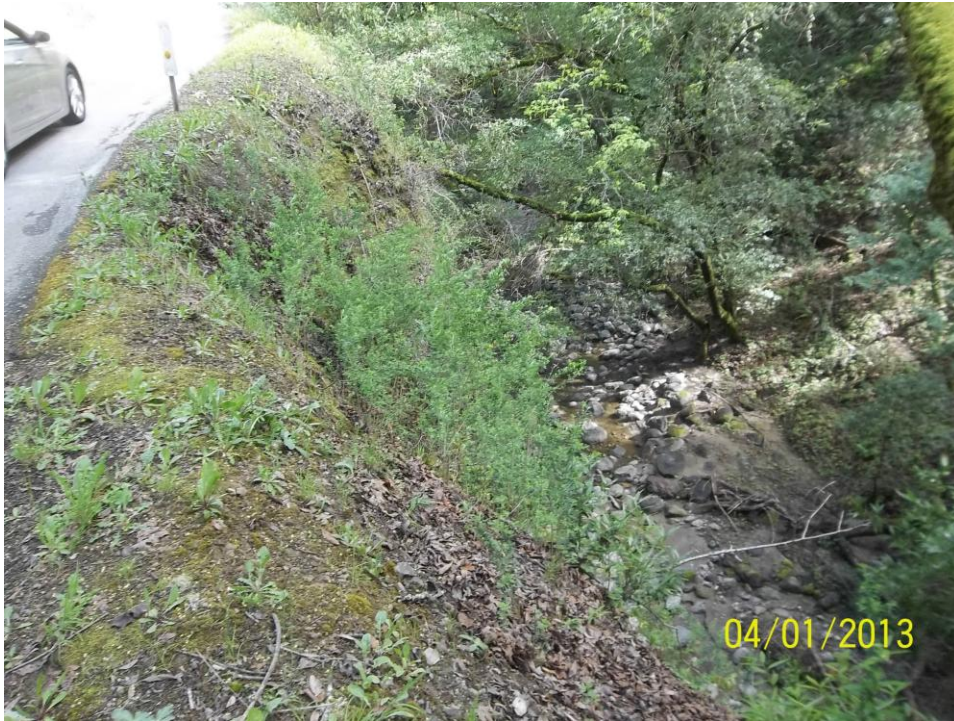
The second slope failure at Site 2 is approximately 60 feet north from the first location described above. At this location, soil nailing and a shotcrete face is also proposed, and the length of the repair is estimated to be 30 feet (Photo 5).

Photo 5 – Site 2: Photo showing the smaller slip-out immediately north of the slip-out shown in Photo 6. Note the colonization of invasive French broom in the disturbed slide area.

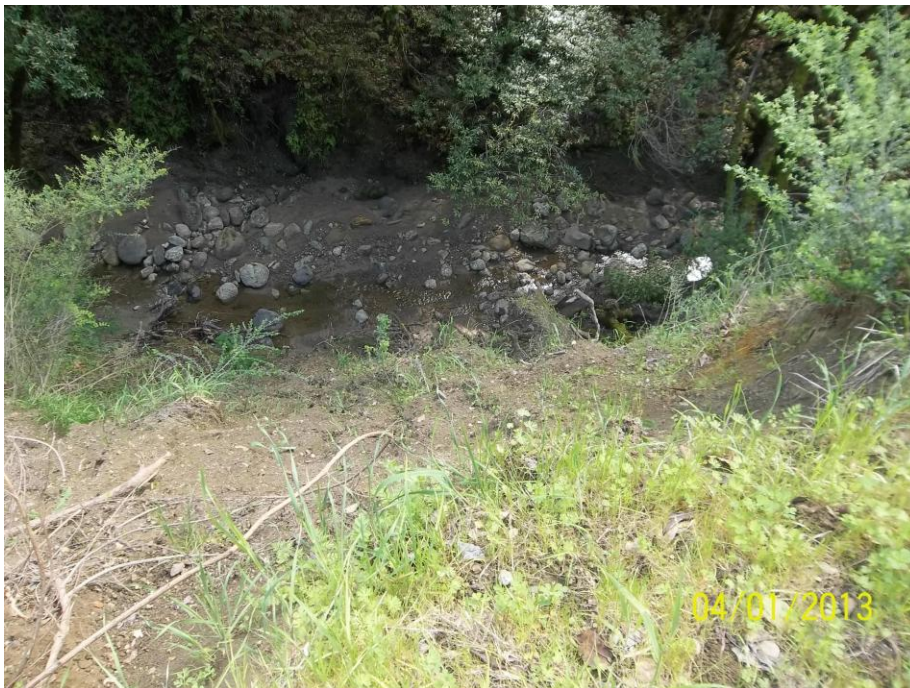
Photo 6 – Site 2: Photo showing near vertical drop from the roadway at the Site 2 slip-out located closest to the Joaquin Road intersection.
